## Spring Energised Seals for Cryogenic Quick Connect / Disconnect Coupler

SEALS FOR CRYOGENIC QCDC COUPLER

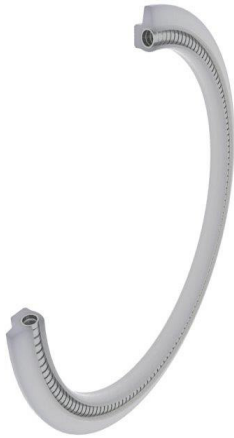
DMR designed a bespoke spring energised seal which would utilise our customers existing metalwork, this meant no redesign work was required by our client. The combination of a special high-load spring energiser and fluoropolymer seal jacket was proposed to enable the seal to provide leak-tight performance and resist shrinkage while performing at cryogenic temperatures.

Seals were supplied to our customer 3 days after our initial assessment and easily installed into the QCDC after the initial lead-in chamfer modification had been made. The seal was placed under rigorous quick connect / disconnect procedures at  $-196^{\circ}\text{C}$  for 168 hours and zero leakage was recorded. Our client was so pleased with the results of the test and the speed in which DMR had reacted to their problem that we were invited to look at a secondary seal design. This new seal was similar to the initial brief, but with an angled sealing face as per the image on the right of this page. Tests were repeated and zero leakage was once again reported.
