Leaking Seat Seals on Ball Valves

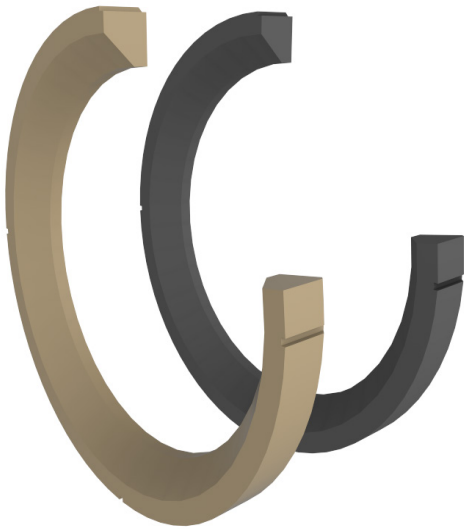
We visited our client to establish the issues that were being witnessed and to see the valve being tested under service conditions. Once again the valves were not achieving the specified leak rate unless the torque values placed down on the ball were almost doubled. We asked for the valve to be stripped down so that we could examine the existing seat seals and take some measurements of the ball in the seat. The seat seals had been manufactured by another supplier in Virgin PEEK material and upon examination it was suggested by DMR that the surface finish of the actual seat seals was a cause for concern and could be creating a leak path around the ball itself.

DMR were supplied with a full manufacturing drawing of the Virgin PEEK seat seal by our client while on site. The next day we drew the part in our CAD/CAM system and manufactured new parts in Virgin PEEK and a special lubricated PEEK material, while utilising our own design of cutting tools and special machining techniques to achieve a superior surface finish on these parts. The final process was to then put the parts through a superfinish cycle in one of our de-burring machines.

The new sample seat seals were delivered to our customer within 2 days of our initial assessment and the parts manufactured from virgin PEEK were assembled into the ball valve to undergo testing. By the end of the test it was confirmed that the seat seals had passed both the leakage and torque requirements and actually exceeded them by 50% and 10% respectively. Our client then tested the special lubricated PEEK seat seals and were astonished to report the same 50% improvement in the leak tightness requirement and a staggering 33% reduction on the original specified torque requirement. Our client delivered their valves on time and stipulated that DMR Seals be their sole supplier for both Spring energised lip seals and soft seat inserts.
